CH-54
Marshall Hall
Marshall Hall Road (MD 227)
Bryans Road
Federal

NATIONAL REGISTER OF HISTORIC PLACES
INVENTORY -- NOMINATION FORMSEE INSTRUCTIONS IN *HOW TO COMPLETE NATIONAL REGISTER FORMS*
TYPE ALL ENTRIES -- COMPLETE APPLICABLE SECTIONS**1 NAME**

MARSHALL HALL

7 DESCRIPTION

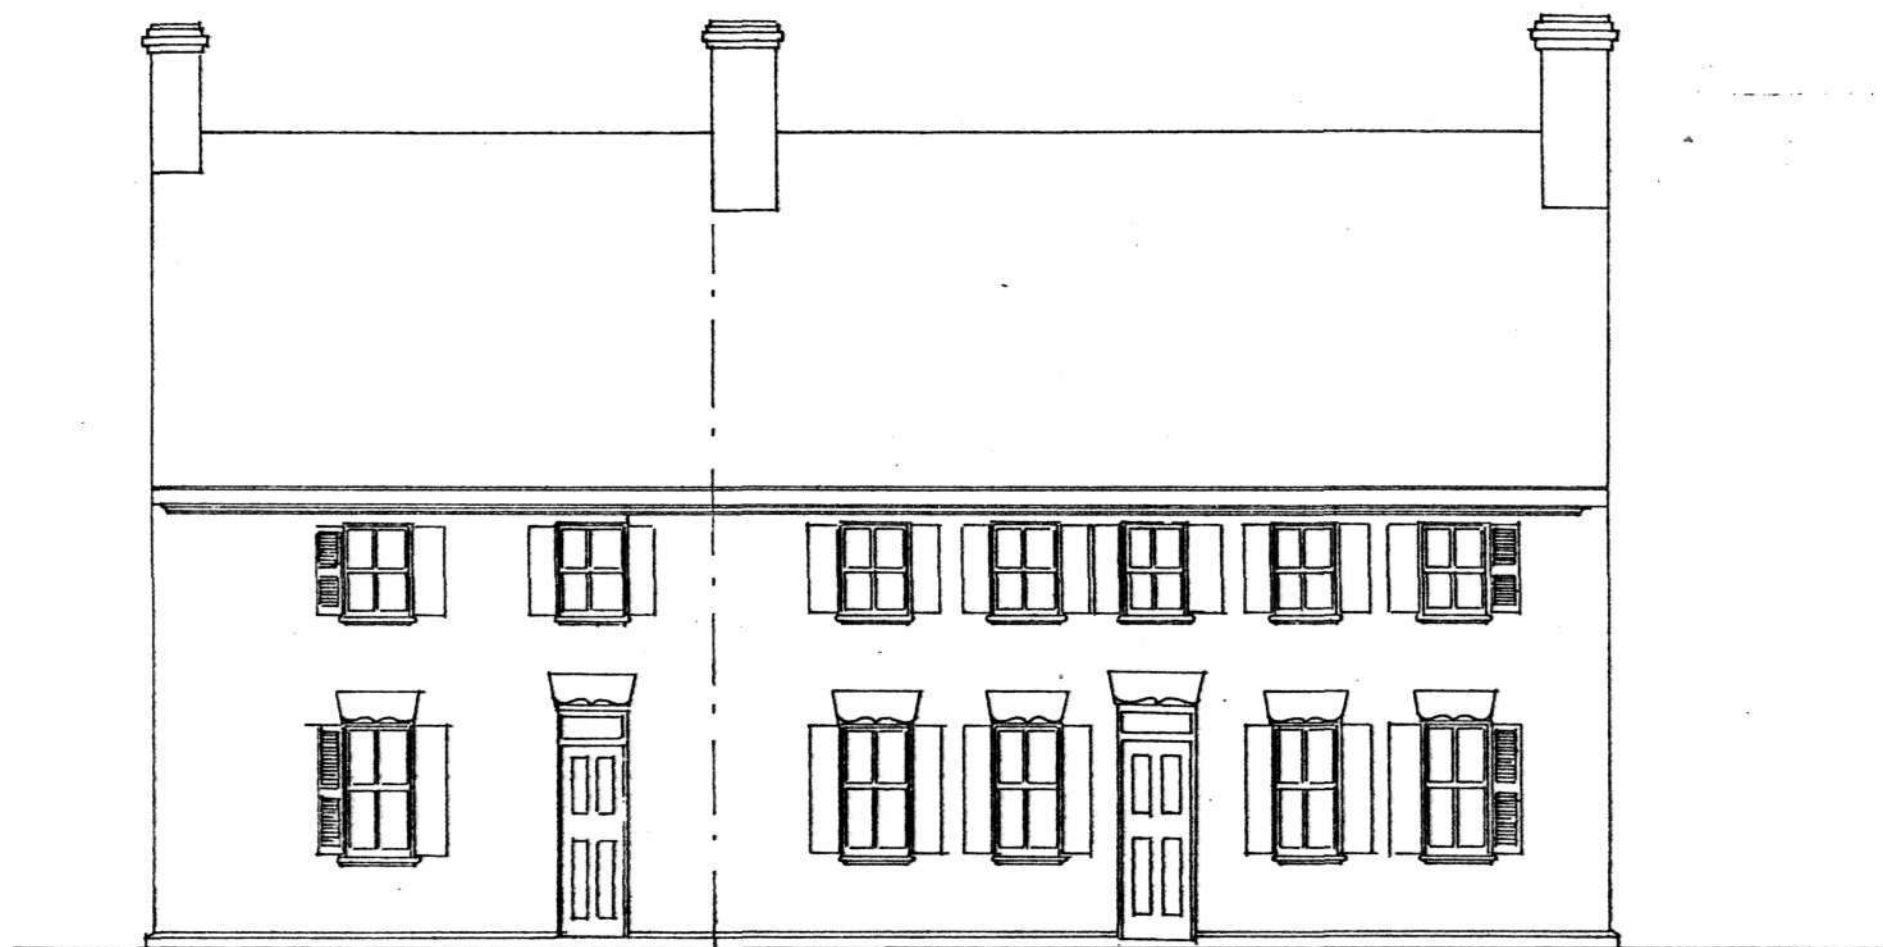
• Marshall Hall 'Mansion'
North Elevation, Front
scale: $\frac{1}{8}$ in. = 1 ft.

The river front (north facade) of the 60 X 30 foot house is seven bays in length (see Figure 1). The first five bays from the west end constitute the original house of circa 1725; the two easternmost bays date from an extension of the house made in about 1760. On the first floor the original five bays consist of a center door flanked by two windows on each side. These windows and the door have splayed brick arches of rubbed and gauged brick, the bases of which are molded in a double-ogee pattern creating a highly decorative effect.² The five similarly spaced windows above have flat unornamented heads that are flush with the base of the roof cornice. All the windows have sash of two-over-two panes that are of Victorian vintage, although the windows themselves occupy the original locations. The doorway frames a modern door and transom and is now slightly narrower than it was originally.

The two first and second floor bays of the addition (a window and a door on the first floor and two windows above) also occupy the original locations and have two-over-two Victorian sash. The doorway frames a modern door and transom; the original width, however, is retained. An interesting feature on this elevation of the addition is the manner in which the bases of the window and door heads of the first floor were crudely chiseled out in an attempt to repeat the decorated flat arches of the four windows and door of the original house.

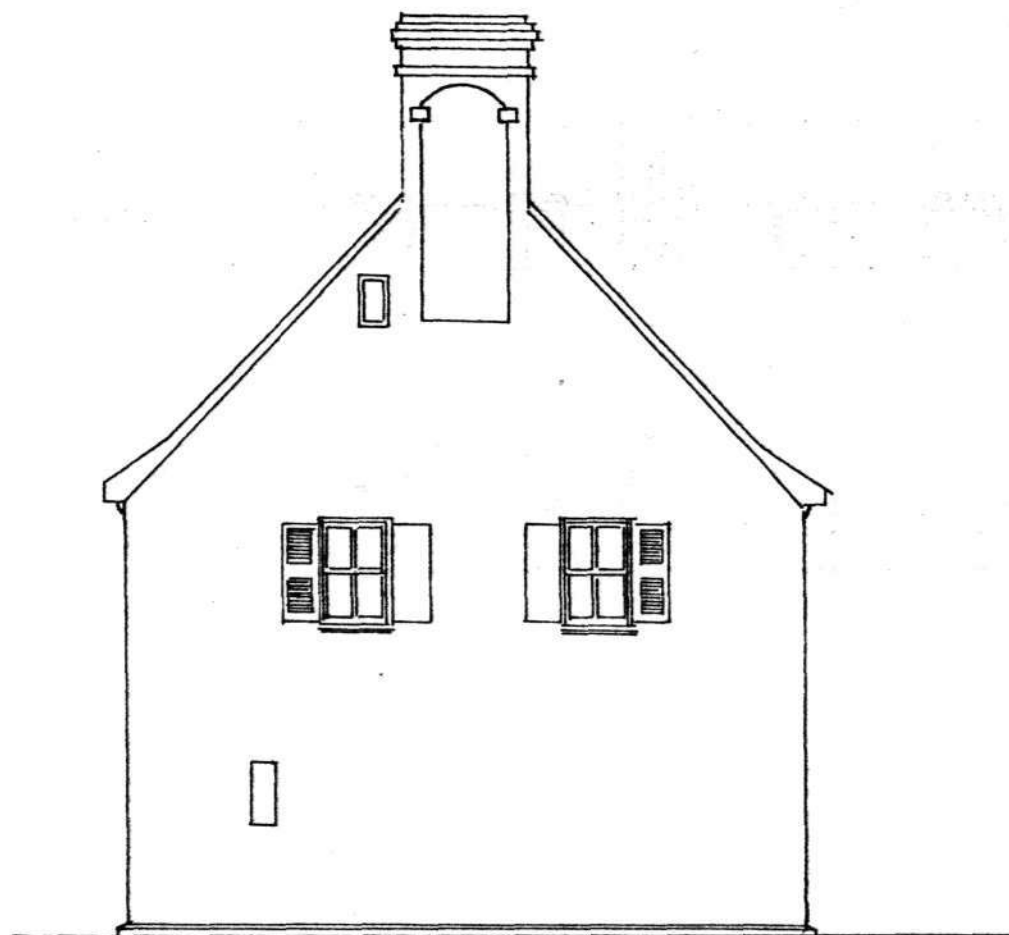
Marshall Hall "Mansion"
West End Elevation
scale: $\frac{3}{8}$ in. = 1 ft.

Before renovation of the house in 1966, the west end displayed a large flush chimney decorated on its outside face by an arched blind panel extending up from about the middle of the gable to just below the corbeled chimney cap (see Figure 2).³ In 1966 the chimney stack was rebuilt above the gable peak and, though the panel was rebuilt, the arch was not. When first built, the west end was broken only by a very narrow closet window near the north end of the first floor and an even smaller louvered vent near the top of the gable. Of these two openings, only the attic vent remains, the closet window having been bricked up at an unknown date. At the present time, there are two second floor windows that replaced doors introduced when a veranda was added to the house in the late nineteenth century. The east end of the house is now devoid of any openings as the two windows originally near the north end of the first floor were later bricked up.

Of the 3 chimneys only the two from the W. end are original. These chimneys are unique in Charles County in that they retain an arched inset of channel running on their outside walls to from the attic gable level to the base of the chimney stack. While the W. chimney design has managed to survive the E. chimney had its inset filled in when the wing was added. The chimney lays are well formed and probably once displayed ornamental plaster pecking bands. The arched chimney inset is a Tudor influenced feature & is found on a few Md. Hous. of the 1st 1/2 of the 18th century.

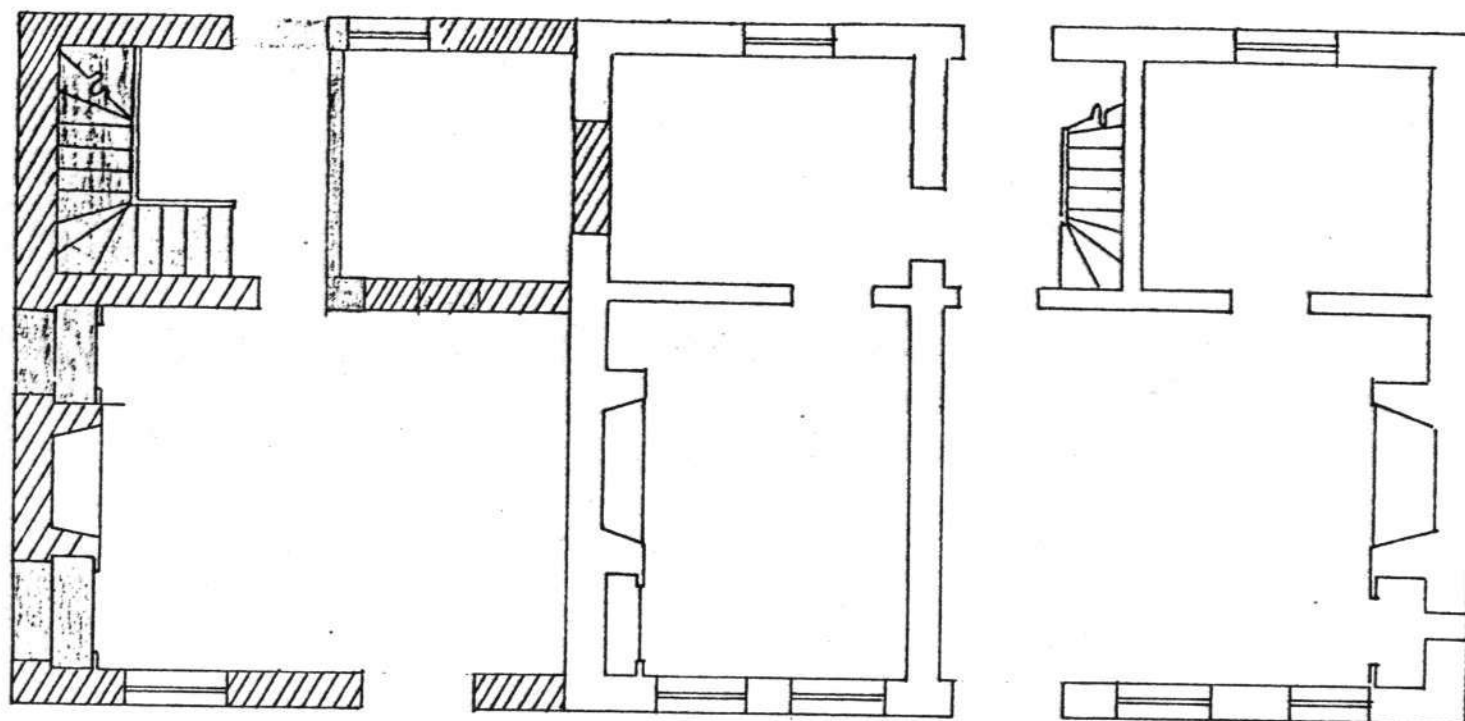
✧ Marshall Hall "Mansion"
GROUND LEVEL FLOOR PLAN ✧

The ground floor room configuration of the older, circa 1725 house consisted of four rooms with a short, centered, rear stair hall, a plan characteristic of Charles County architecture throughout the eighteenth century.⁴ The front entrance door opened into the largest (northwest) of the four rooms, which had walls completely covered with fielded panels, as well as heavily molded baseboards, chairrails and ceiling cornices, paneled window and door reveals, and a plastered ceiling. On the west wall was an expansive fireplace with rounded back, framed by a wide bolection molding. This fireplace was made smaller in size in the late nineteenth century and a new, Victorian-style mantel installed within the area framed by the earlier bolection molding. Flanking the fireplace on the north side is a shallow closet with paneled door and shelved interior. The closet was once lighted by a small window in its west wall which has since been bricked up and plastered over.

In 1966 the interior of Marshall Hall was renovated for conversion to offices. The basic plan was retained (see Figure 3), as

The initial plan of the addition included a large, full width front room that from all available evidence served as a kitchen (see Figure 3). The rear section of the first floor was a recessed porch, open to the outside by a wide arched doorway. The only early features known are that the north kitchen room had plastered walls, exposed beaded ceiling joists, a large fireplace on its east wall flanked by a window on each side, a door and window in its north wall, and a door and window on the south side. The kitchen floor might have been wood, as it is today, but it was probably paved with brick, as was the porch floor. In about 1800 the kitchen was remodeled to serve as an additional living area by plastering over the ceiling and installing new baseboards, chair-rails and a ceiling cornice. The fireplace was made smaller and a Federal-style mantel provided. The two windows flanking the fireplace were bricked up and two cupboards, each with two sets of paneled double doors, were installed in these areas. The porch was divided into two rooms and the former arched doorway filled in and a single door and window installed in its place. It is believed that the existing stair on the east wall of the southeast rear room was provided at this time, probably replacing a stair in the former kitchen room.

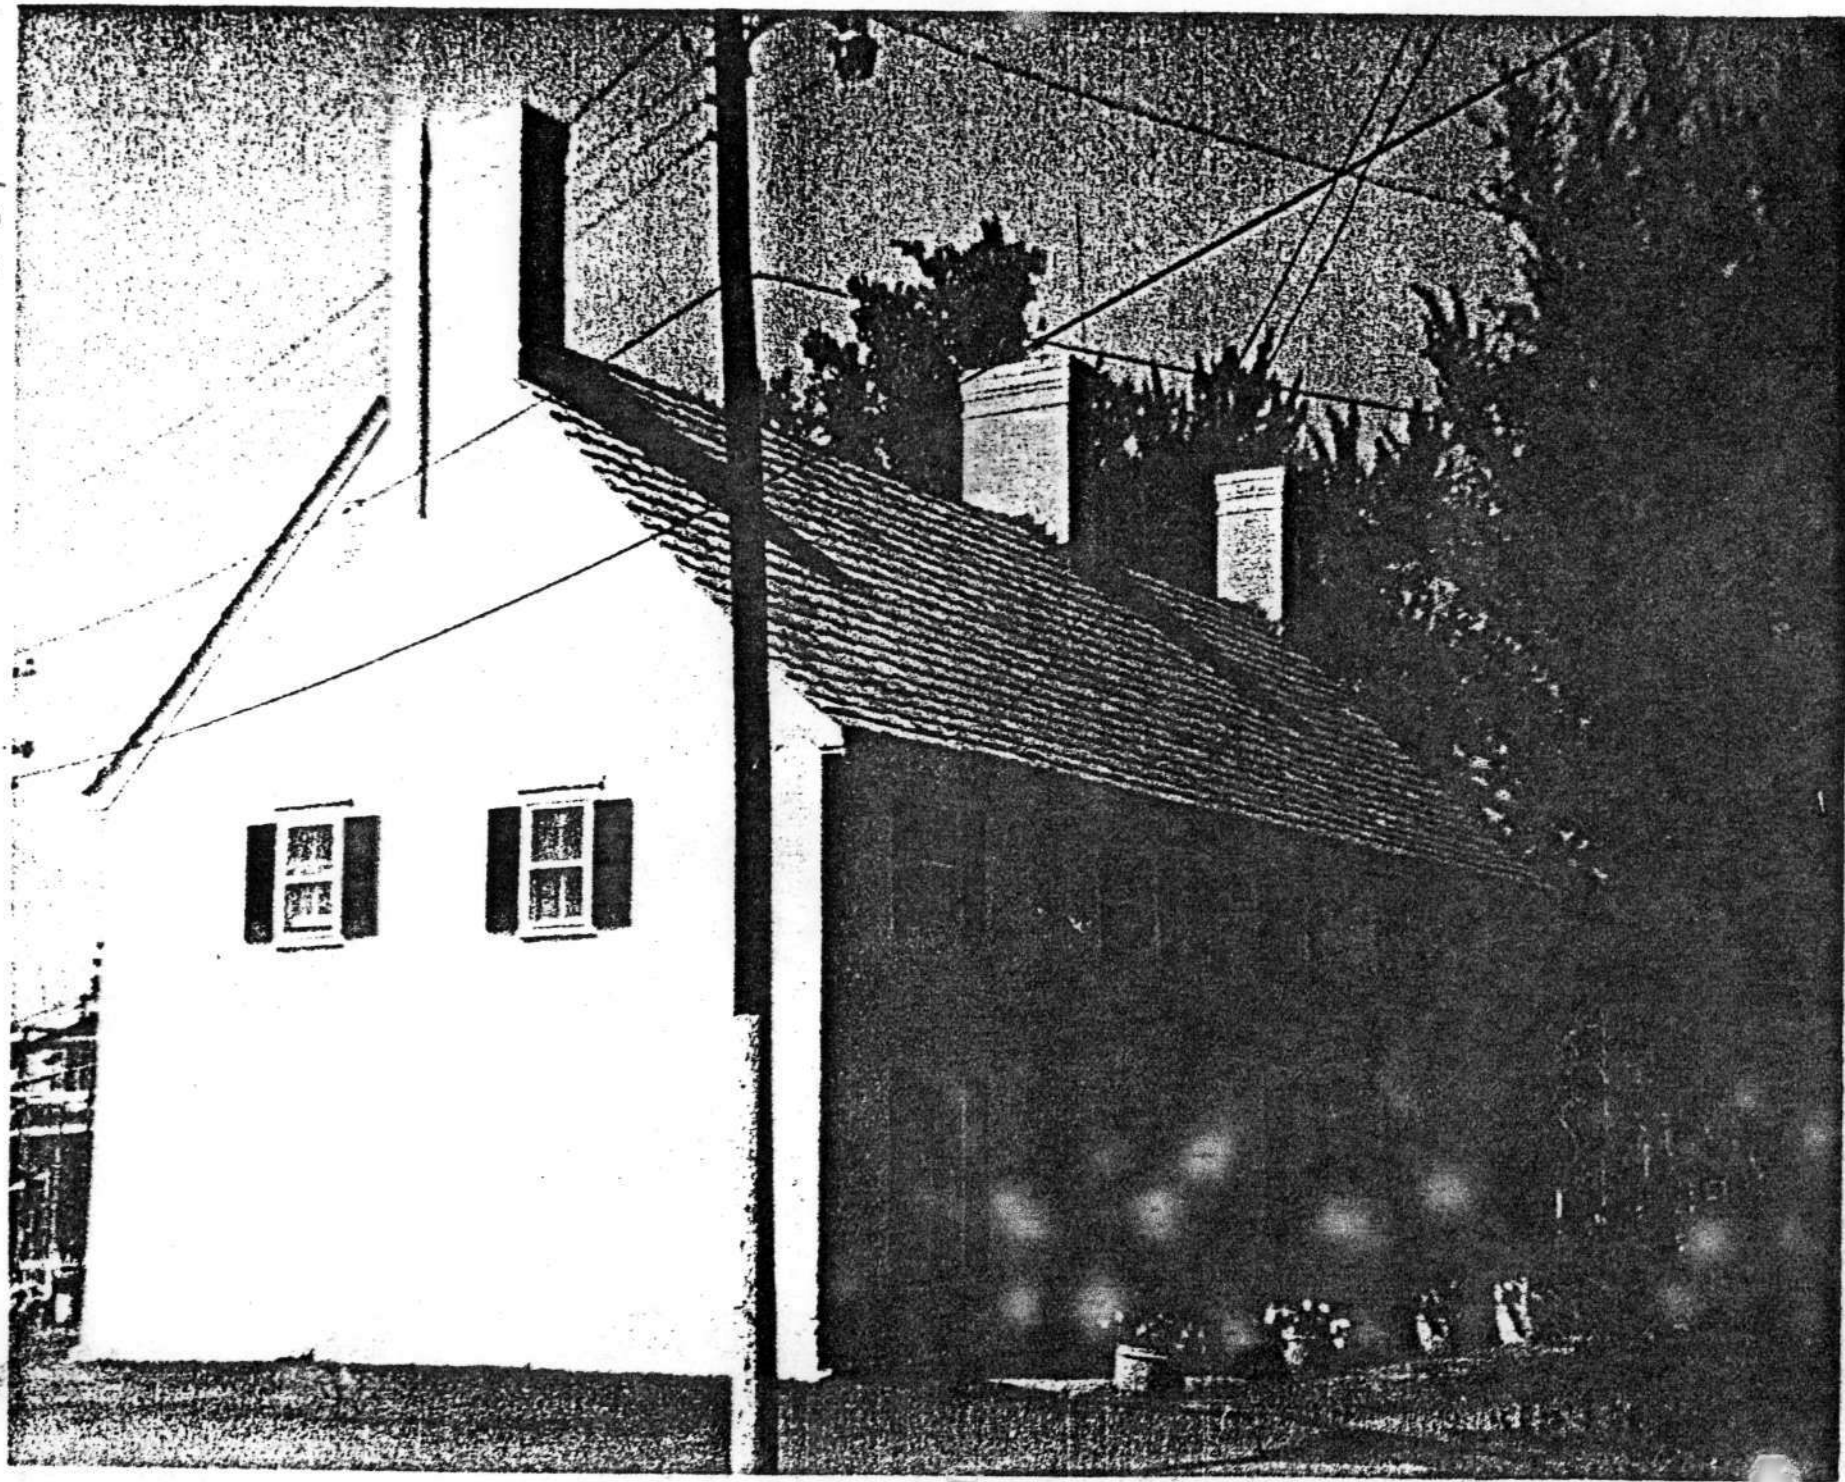
CH-54
Marshall Hall
c. 1900
South elevation

the older part, are unornamented and flush with the roof cornice. All windows on this elevation also held 2/2 Victorian sash. A photograph taken c. 1900 shows a Victorian porch with elaborate brackets spanning this entire elevation. Before renovation in 1966, the west gable end displayed a large flush chimney decorated on its outside face by an arched blind panel extending up from about the middle of the gable to just below the corbeled chimney cap. In 1966 the chimney stack was rebuilt above the gable peak, and though the panel was rebuilt, the arch was not. A closet window in this gable end was bricked up at an unknown date, as were two window openings on the east end of the house. Two windows pierce the second floor of the west gable end. The roof of the building flared at the eaves. Photographs from the 1950s and 60s show a modillioned cornice with ogee crown and bed moldings decorating the front and rear elevations, but this was removed in 1966. The basic interior plan was retained, along with a substantial amount of interior fabric. In 1976, the National Park Service bought the property, and planned to restore the building. On October 17, 1981 the house was completely gutted by an arson fire, leaving only the brick walls standing. The 60' x 30' walls were stabilized and fenced off until the building suffered yet another accident on January 12, 2003, when a large truck drove straight through the center of the building and out the other side. The bays destroyed on the south facade were the entrance bay and the bay to its east, and on the north facade, the entrance bay and the two to its east. Effectively, the central third of the building was completely destroyed.
